**AIR QUALITY IMPROVEMENT PROGRAM (AQIP)
(Pursuant to AB 118)
ADVANCED TECHNOLOGY DEMONSTRATION PROJECT**

**Final Report of Tier IV Particulate Matter Retrofit System on
UPY-2755 (Genset Switch Locomotive)**

December 2, 2013

Prepared by:
Jose G. Ramirez
Sr. Project Engineer, Johnson Matthey SEC LLC

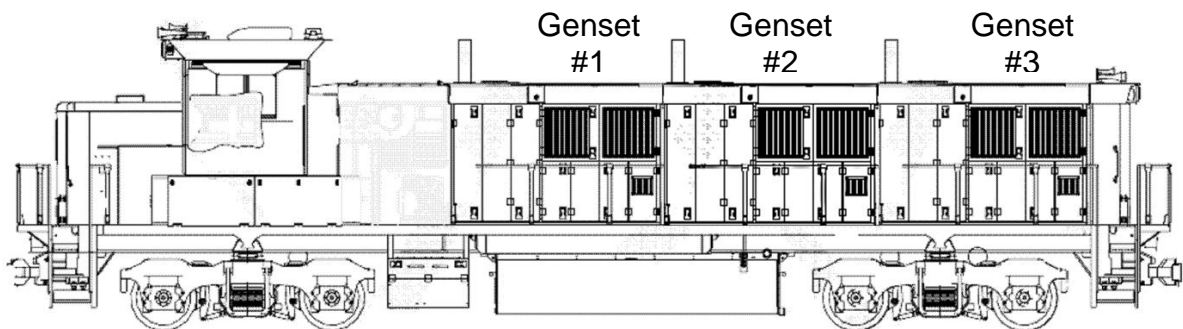
locomotive is powered by three engine-driven generator sets, Model 572RDL. The 19 liter Cummins QSK19C engine is an in-line six cylinder configuration, turbocharged, air-to-air after-cooled, and is common rail injected. Each of the three engines is capable of developing 700 horsepower (522 kW) for a total locomotive power output of 2,100 horsepower (1,570 kW) with a nominal ISO 8178 D2 weighted PM emission factor of 0.2 g/(bhp-hr).

Figure: 1 Union Pacific UPY-2755 schematic of 3 GS-21B ULEL Switch Locomotive

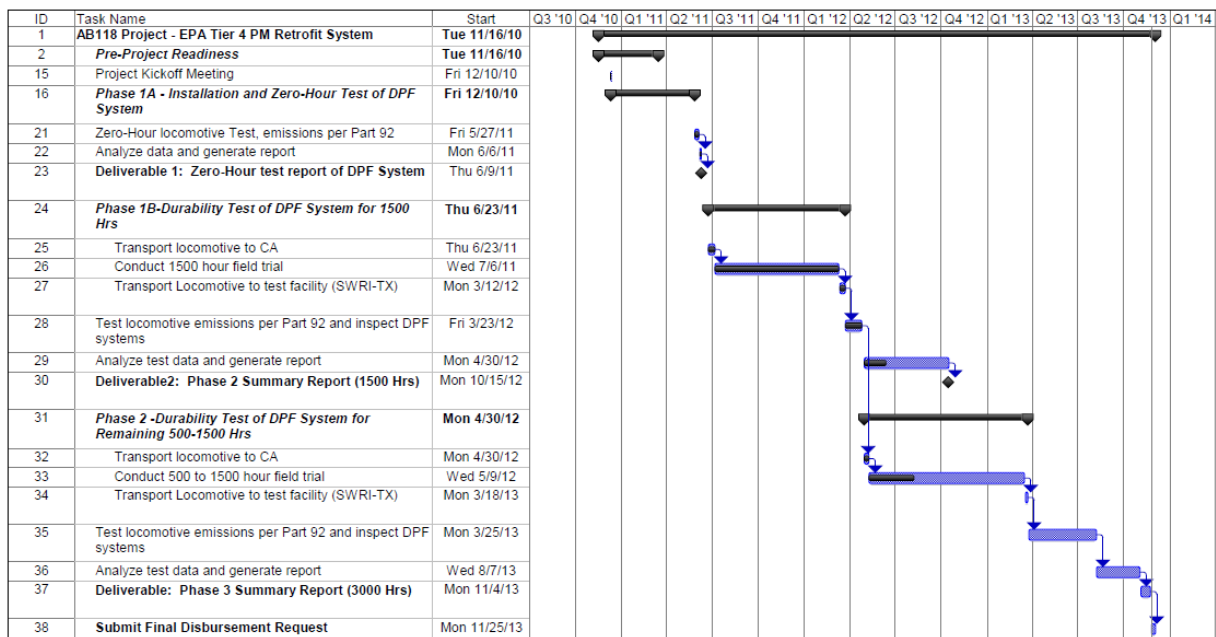
Figure 2: Project Timeline

Due to some engine related malfunctions, the project schedule was pushed back to a completion date of December 2013, as compared to June 2013; see Appendix-C. The mechanical failures experienced during the demonstration have been deemed unrelated to the installation and independent of the use of the Johnson Matthey L-CCRT™ system DPF retrofit by Union Pacific mechanical staff. The new schedule, which included the project delays and new projections, is shown in Figure 2. At this point, all phases have been completed, and verification testing has successfully proven the performance of the L-CCRT™.

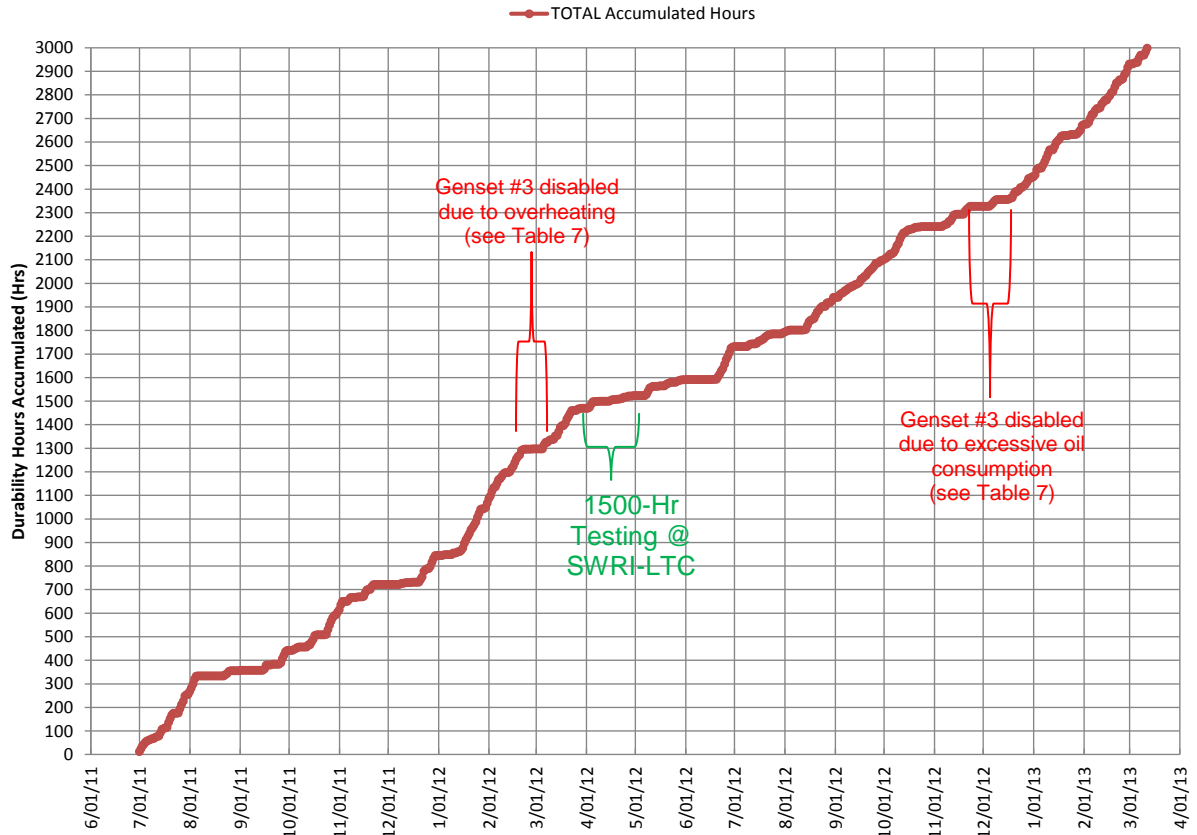
The 3000-hour exhaust emission tests using the Federal Test Procedure (FTP) for locomotives, as detailed in Title 40 of the U. S. Code of Federal Regulations (CFR), Part 92, Subpart B, were performed on 4/12/13, 04/15/13 and 08/06/13. The durability operation of the locomotive began on 6/23/11, as it was picked up from the Southwest Research Institute Locomotive Technology Center (SWRI-LTC) and transported to the Union Pacific Railroad Company (UPRR) Mead Yard in Wilmington, California. The accumulation of 3000 hours was completed on 03/13/13. The rate of accumulation of the 3000-hours between those dates is presented in Figure 3.

Figure 3: Durability Hour Accumulation for 3000 Hour Durability Period

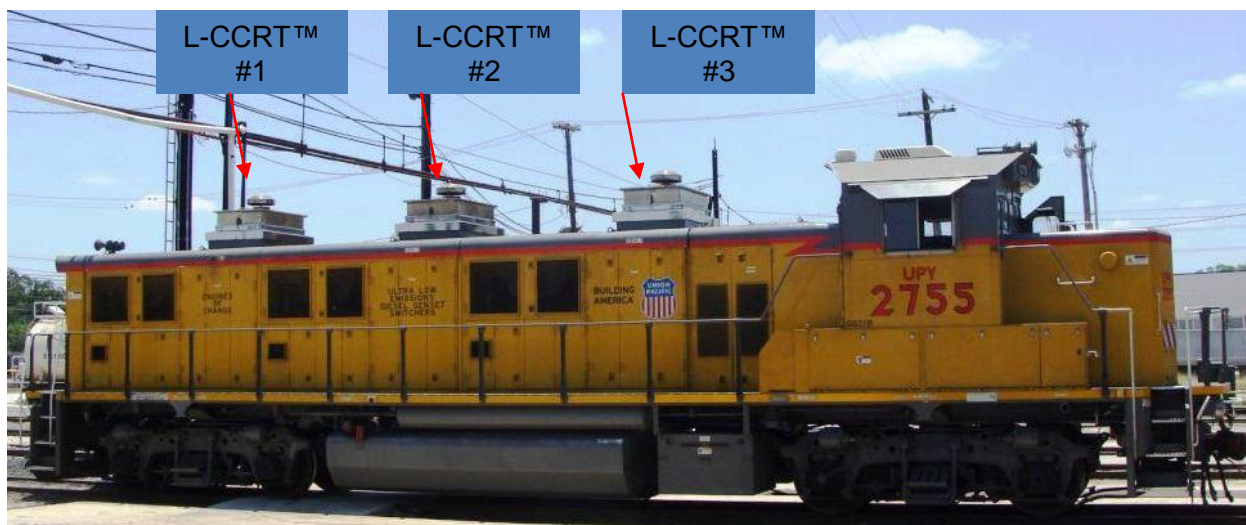
The L-CCRT Installation began on April 2011 and was completed on May 20, 2011. The installation of the 3 L-CCRT's is shown in Figures 4 and 5, below; which show the locomotive UPY-2755 before and after the retrofit installation.

Figure 4: Union Pacific Switch Locomotive UPY-2755 fully equipped with 3 L-CCRT's

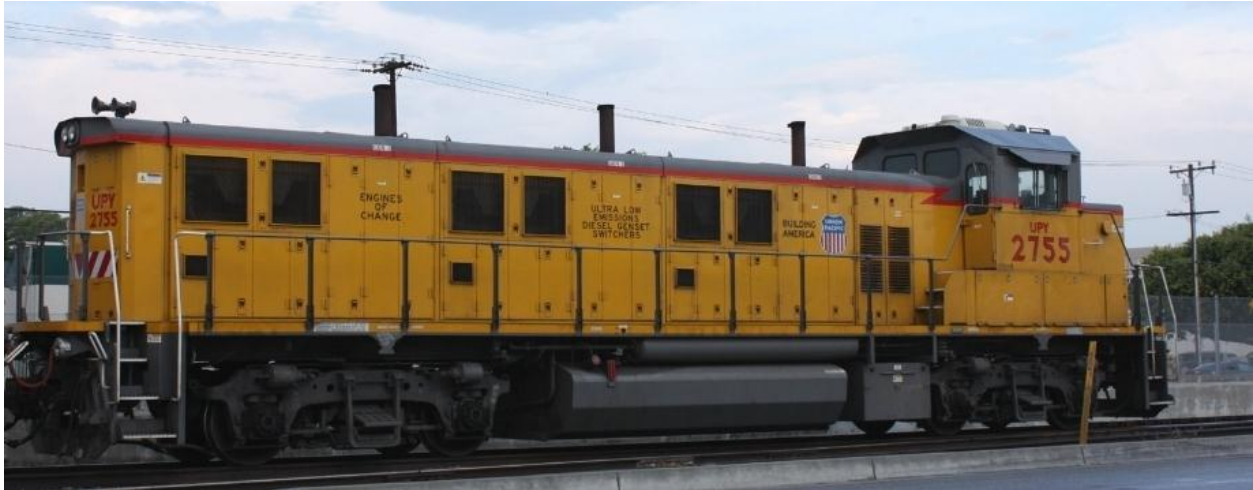
Figure 5: Union Pacific Switch Locomotive UPY-2755 in original state

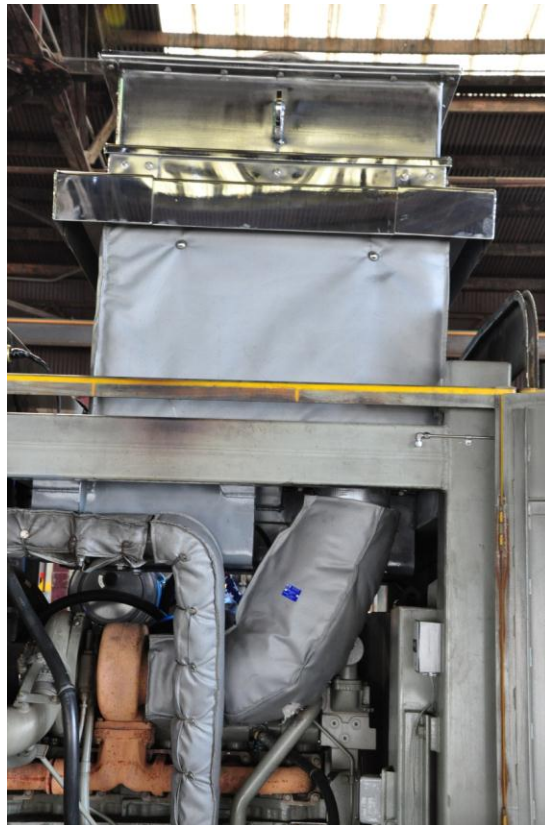
The installation of the L-CCRT's required modification to the engine skid on each of the three Gensets, as shown in Figure 6. The removal of the original engine muffler provided the necessary space to install the unit.

Figure 6: L-CCRT Installed on one Genset of UPY-2755, with Engine Exposed

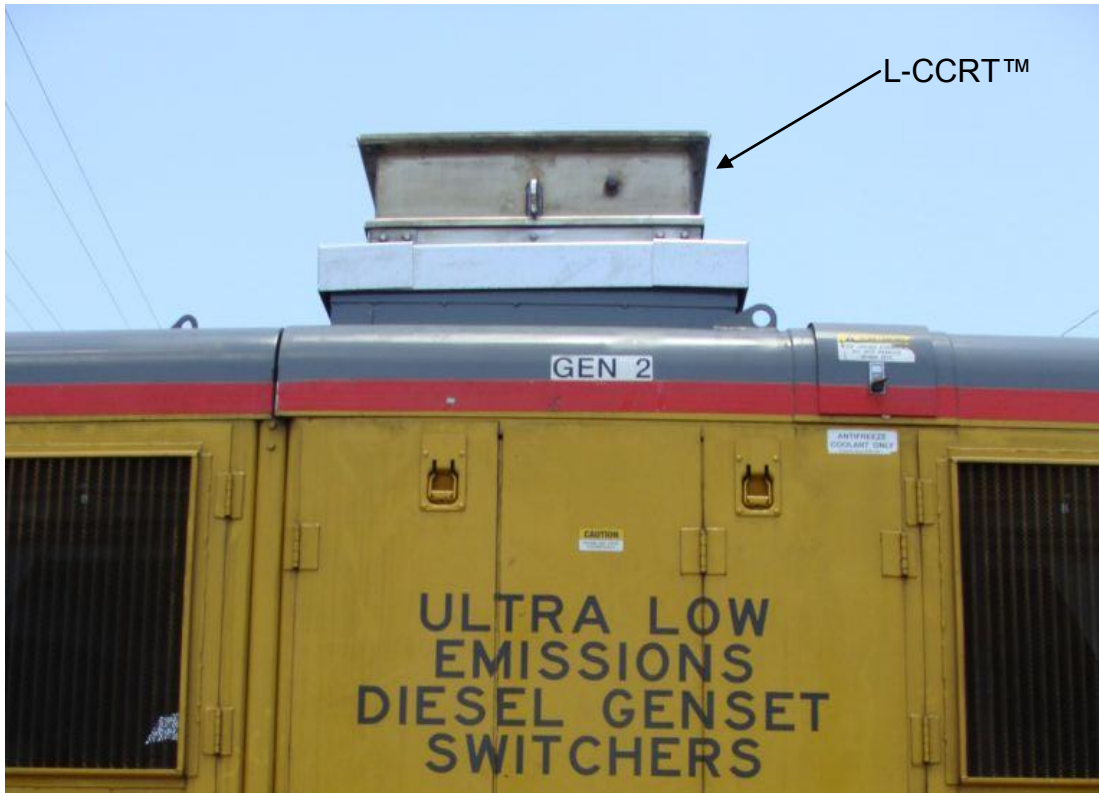
The design of the L-CCRT is intended to operate in a harsh mechanical environment. The mounting design takes into consideration the following:

1. High G-Shock loads related to the switcher coupling during normal revenue service. The design is expected to sustain a high-cycle of 5-G-Shock loads.
2. The High temperature environment (~1050 °F) of the engine exhaust will result in large thermal expansion of the unit during operation. This type of growth was accounted for, and is expected to work in tandem with the 5-G-Shock load rating, as described above.

Figure 7: L-CCRT™ Installed on one genset of UPY-2755, Genset #2

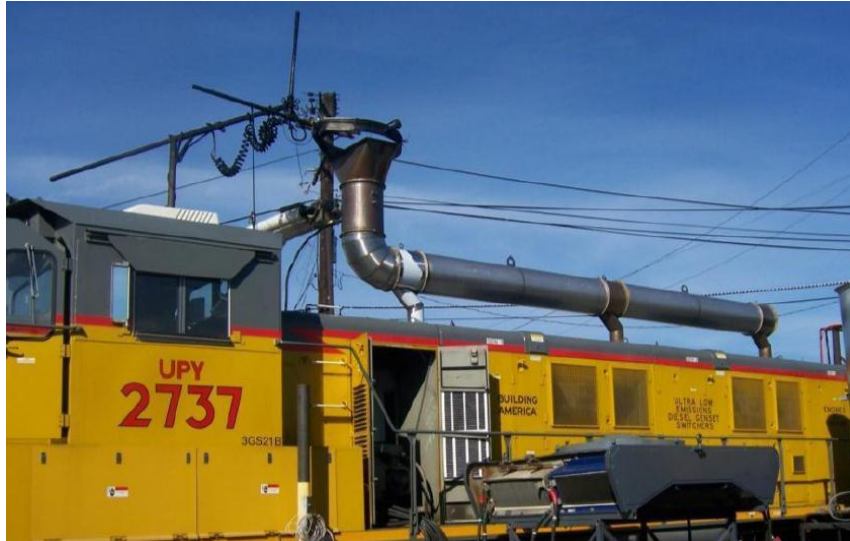
Figure 8: UPY2737 Setup for Baseline Testing by Combining All Three Exhaust Stacks

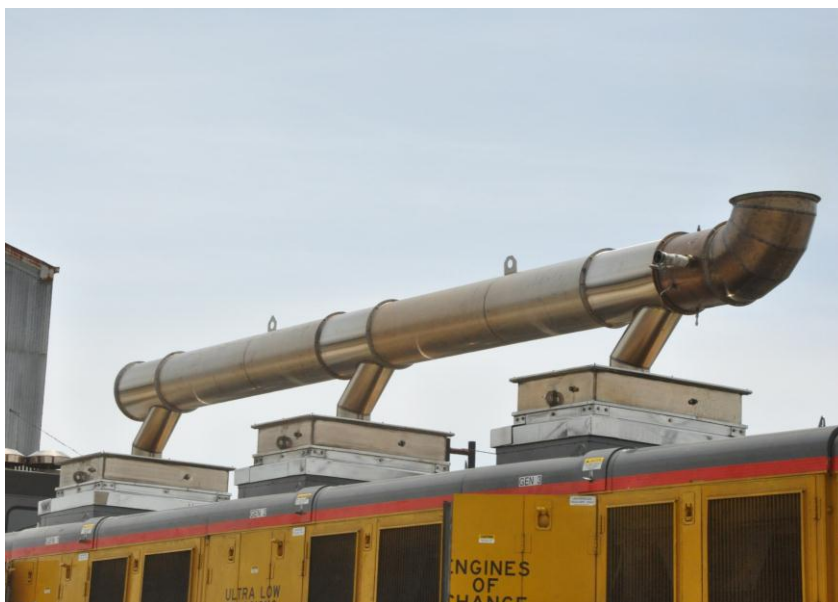
Figure 9: UPY-2755 equipped with 3 L-CCRT's. Exhaust Flow is combined for Part92b Testing

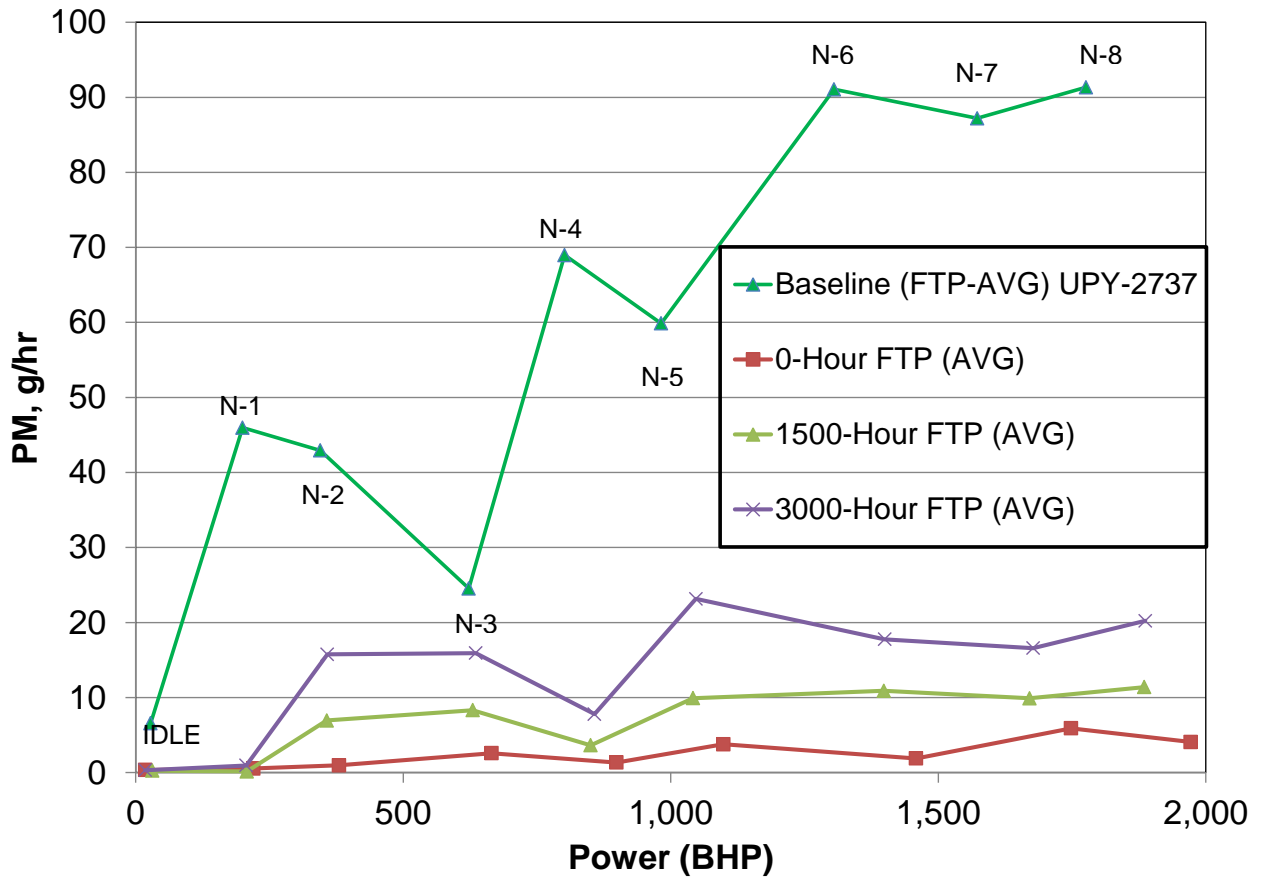
In addition to the baseline test results, the zero-hour, 1500-hour and 3000-hour results from phases 1 and 2 are presented in Table 3, and graphically displayed in Figure 10. The PM outputs in all tests were well below the Tier 4 PM Limit of 0.03 g/(bhp-hr). The final PM values are displayed under the 8th column under PM (g/hp-hr).

Figure 10: Part 92b PM emissions at each notch, for Baseline, 0-hour, 1500-hour and 3000-hour tests

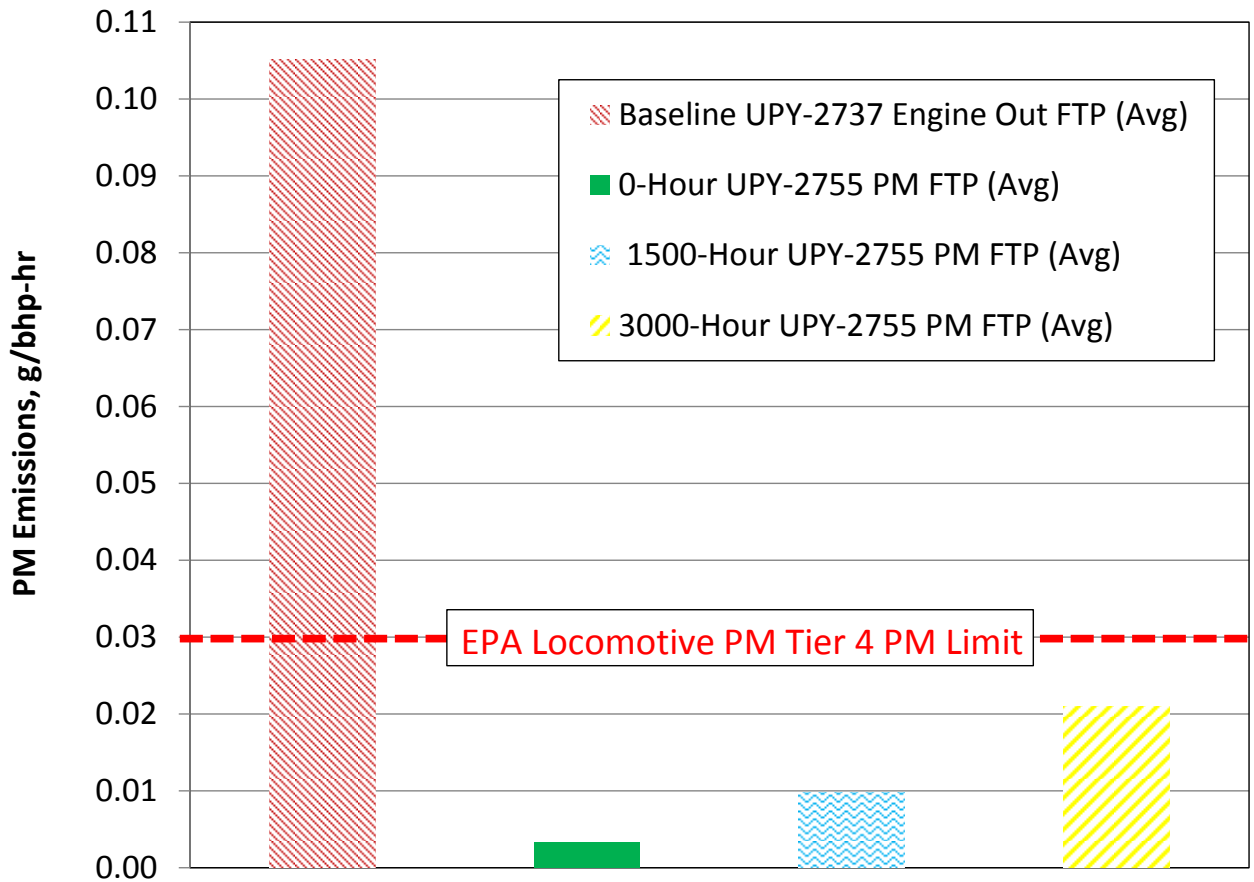
The comparison of the baseline emissions tests and the 3000-hour Tests demonstrated a PM reduction of greater than 80%, or a switch cycle weighted output PM of 0.021 g/(bhp-hr). Given the EPA Tier-4 Switcher Cycle Output PM limit of 0.03 g/(bhp-hr), the results of this test showed that the locomotive PM emissions were about 30% below the Tier-4 PM Limit, as shown in Figure 11. As shown in Figure 10, the PM output at each notch was significantly reduced. The Observed Brake Specific Fuel Consumption (obs.BSFC) in column 4 of Table 3 is representative of the fuel consumption of the locomotive during normal operation. As shown in Appendix A's figure 8, there was no statistically significant change in fuel consumption throughout the 3000 hours of durability service.

Figure 11: PM Results (avg.) comparing the Tier 4 PM Locomotive Limit versus the Baseline Engine Out, the 0-hour Results, 1500-hour and the 3000-hour Results

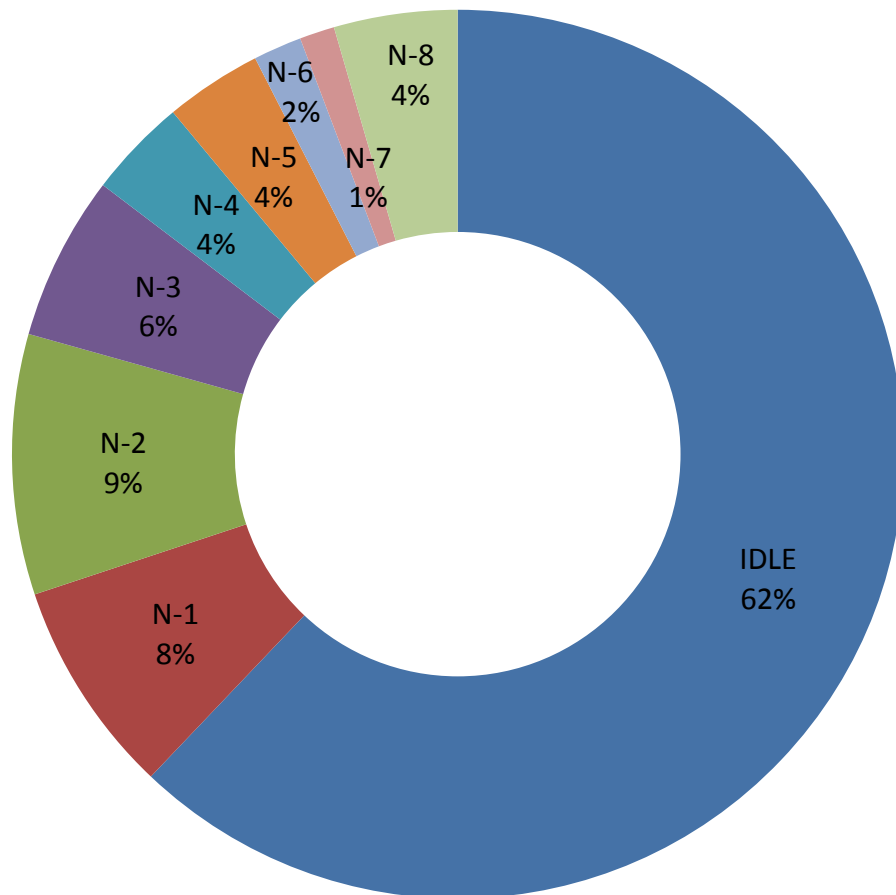
Figure 12: Durability Notch Profile for UPY-2755

The pie chart in Figure 12 demonstrates that a large part of the operational cycle of the switch locomotive is spent in the Idle state. Further, a full eighty percent of the time the operational duty cycle is spent in Idle, Notch-1 and Notch-2.

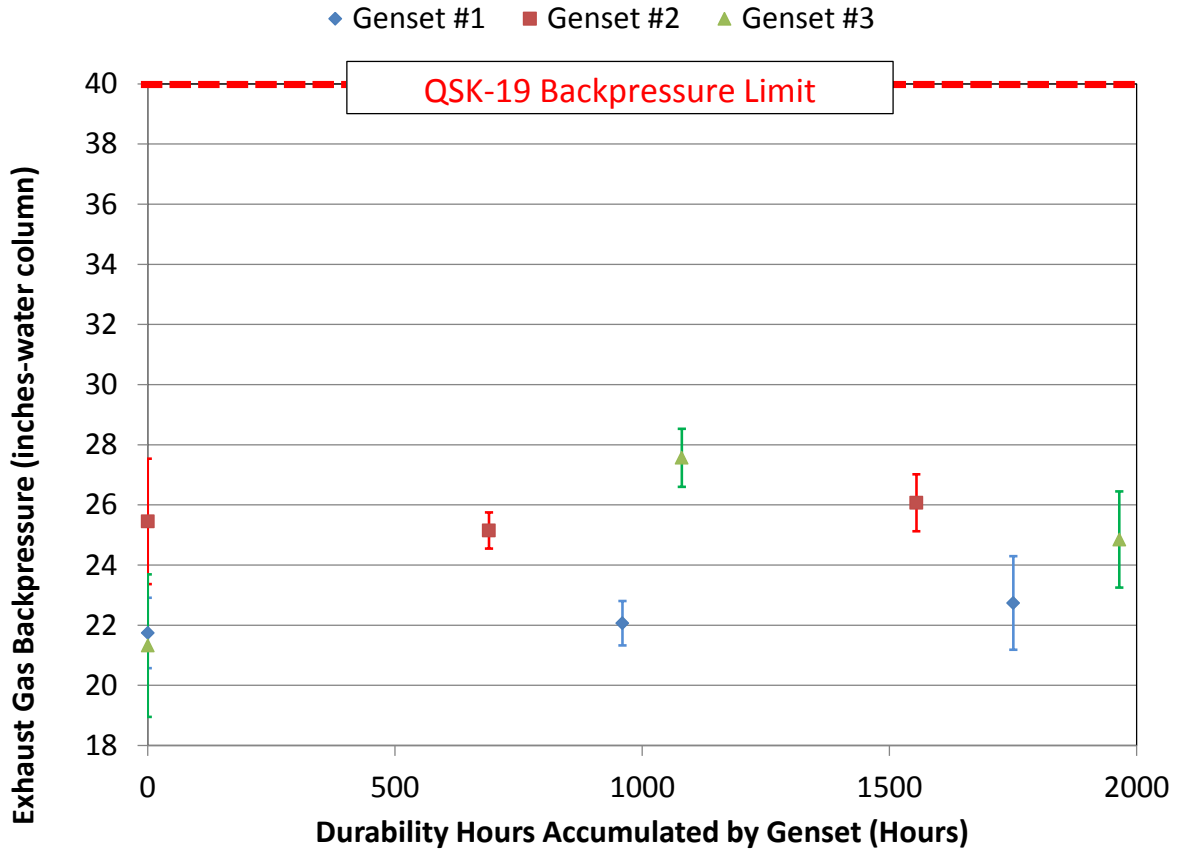
Figure 13: EGP at Notch-3 for zero-hour, 1500-hr and 3000-hr FTP tests, 95% C.I. error bars

At Notch-3, a single genset is activated and is operating at 98% of the full capacity of the engine. The data taken during the zero-hour, 1500-hour and 3000-hour testing was compared at this test point, and is presented in Figure 13 and Table 6. Since data was collected from each of the systems independently, it was possible to determine the individual run time of each Genset, despite the combined locomotive run time of 3000 hours. During previous baseline testing on UPY-2737, it was found that the EGP of the Gensets with the OEM silencer was 37" W.C. (inches of water column). However, as shown in Figure 13 and Table 6, the EGP of the three L-CCRT™'s ranged from 22.7 to 27.6" W.C. after 3000 hours of service.

Test data taken during the FTP cycle at SWRI-LTC was used to determine the performance of the system at both the zero-hour and 1500 hour periods. The overall performance of the DPF system remains within the normal operating EGP of the aftertreatment system, i.e. less than 40 inches of water column pressure. One important test point demonstrating the health of the individual genset system is the Exhaust Gas Pressure, EGP, of the L-CCRT™ at the Notch-3 position.

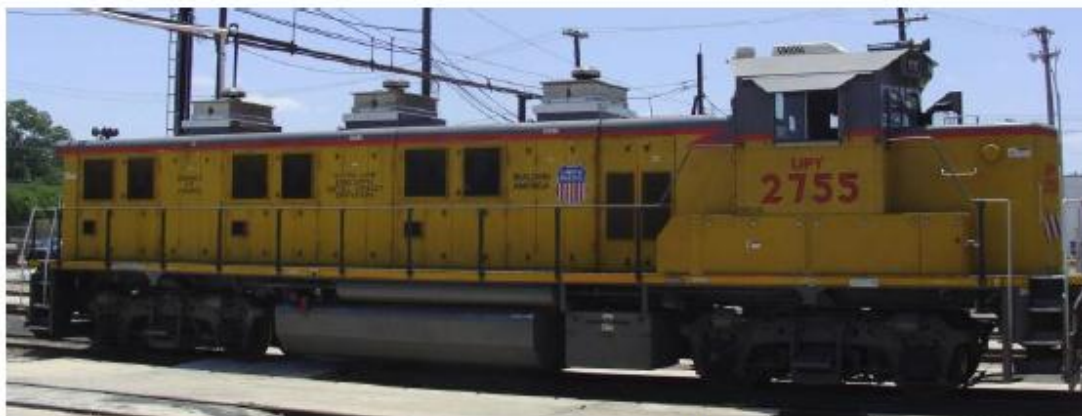
UPY2755 is one of the 70 of this type of locomotives operating in California. These locomotives are certified as EPA Tier 2. UPY2755 is shown in Figure 1, and general locomotive information is shown in Table 1.

Figure 1. Test Locomotive UPY2755

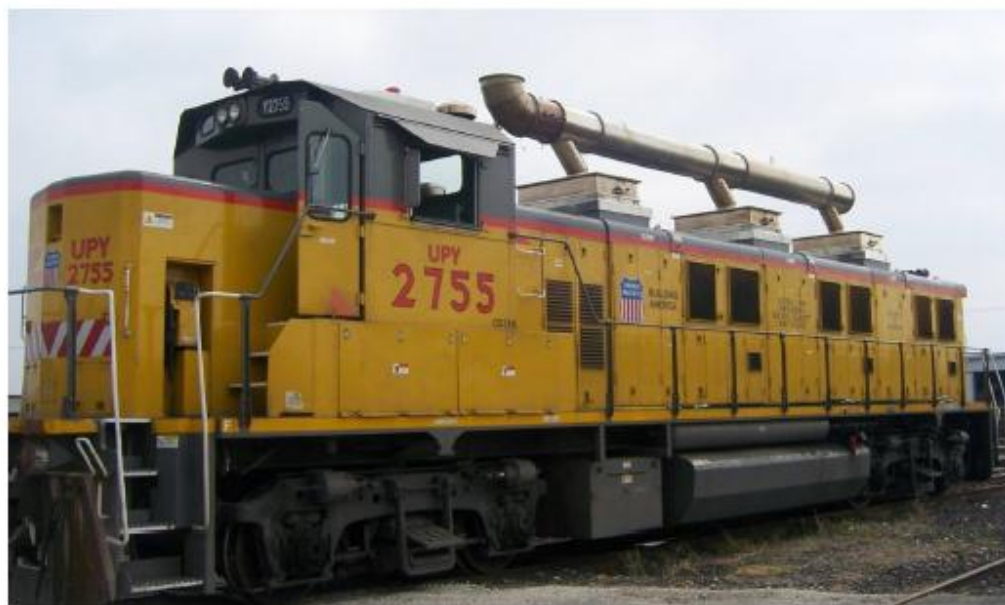
The three exhaust stacks were routed into a common exhaust stack extension or manifold, as shown in Figure 2. The gaseous and particulate sample probes were mounted in a section of manifold near the outlet of the manifold.

Figure 2. UPY2755 With Manifold For Collecting Exhaust From All Three Stacks

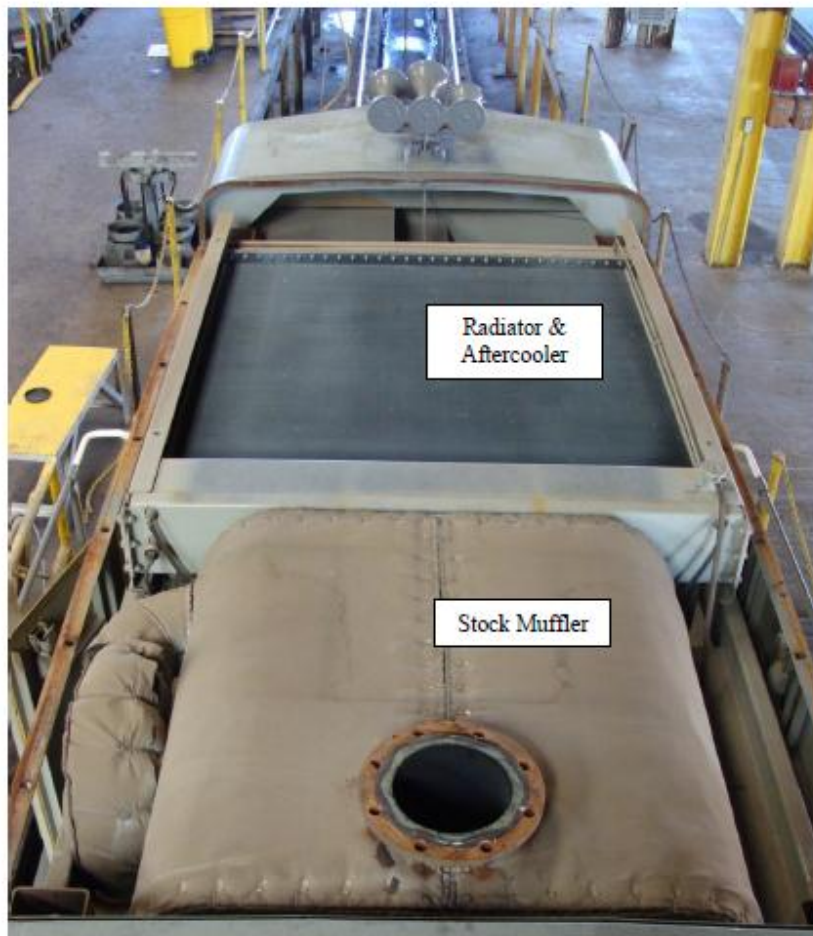
Photos taken during the installation of the JM L-CCRT DPF are shown in Figures 3, 4 and 5. The JM L-CCRT DPF housing was not designed to directly replace the NREC locomotive muffler / silencer, which is shown in Figure 3. The L-CCRT DPF housing, shown in Figure 4 protruded above the long hood roof section over the engine where the muffler / silencer originally mounted. The roof of the long hood was modified to accommodate the installation of the L-CCRT DPF. The interface between the long hood roof of the locomotive and the JM L-CCRT DPF housing was designed to keep rain out of the car body. While taller than the existing locomotive car body, the highest point on the JM L-CCRT DPF was lower than the highest point on the locomotive, and was below the AAR Plate L height limitation. Figure 5 shows the installed JM L-CCRT DPF on all three engines.

Figure 3. Stock Muffler Visible After Removal of Roof Section

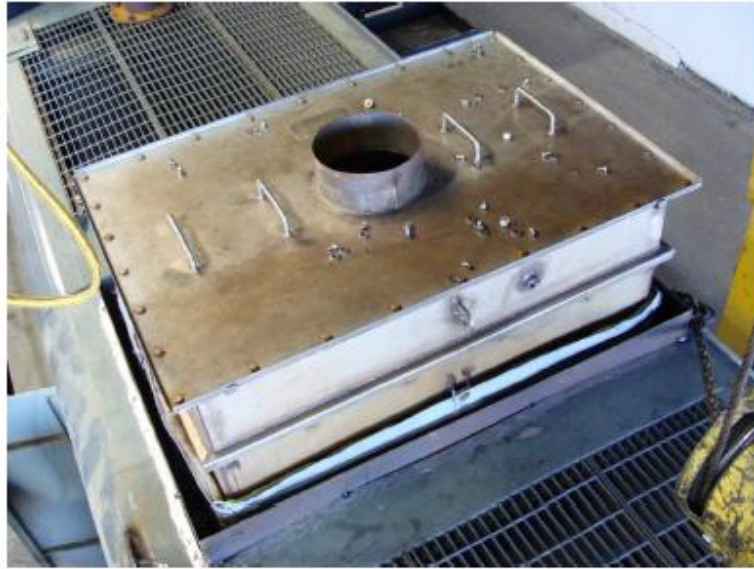
Figure 4. JM L-CCRT DPF Housing with Modified Roof Section

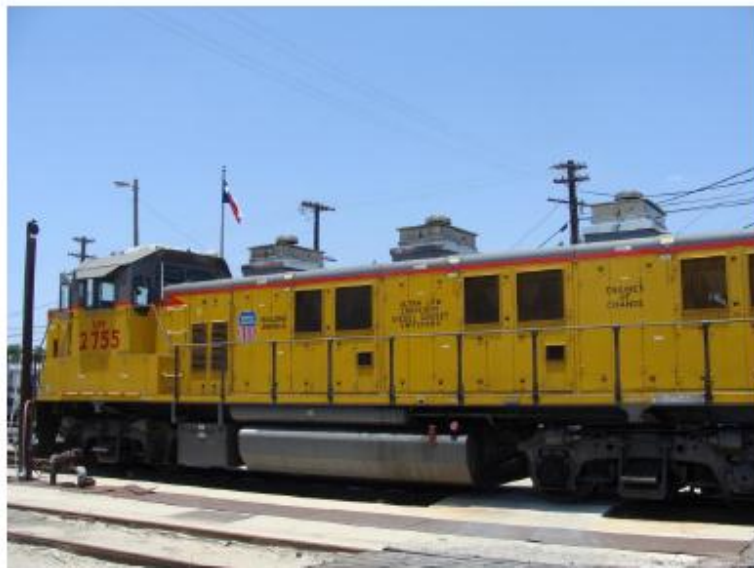
Figure 5. JM L-CCRT DPF Housings Installed

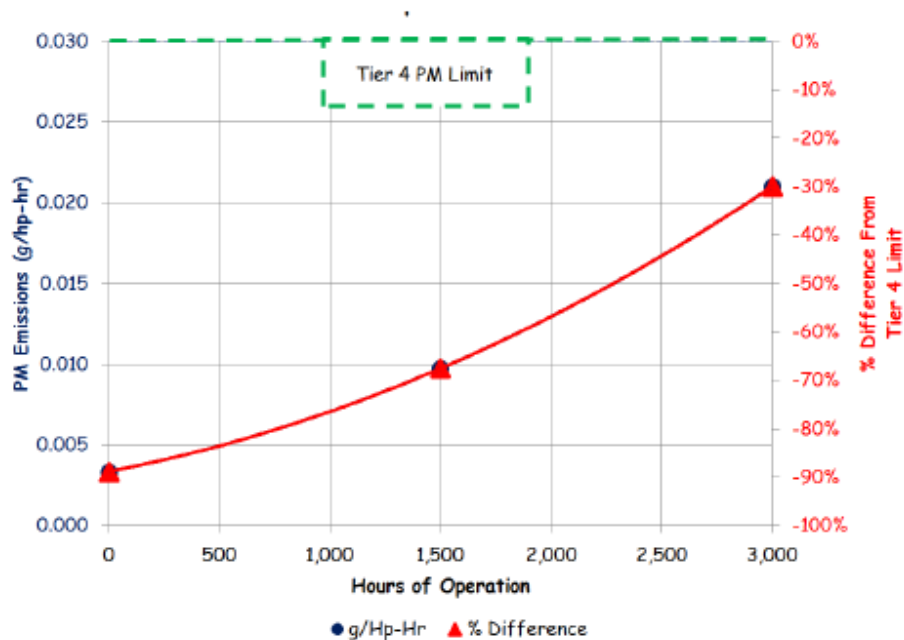
The PM emission trend over the duration of the project is shown in Figure 6. The percent difference between the PM emissions and the Tier 4 limit ranges from 89 percent below the Tier 4 limit at the zero hour test, and 30 percent below the Tier 4 limit for the 3,000 hour test.

Figure 6. Switch Cycle Particulate Emissions Trend

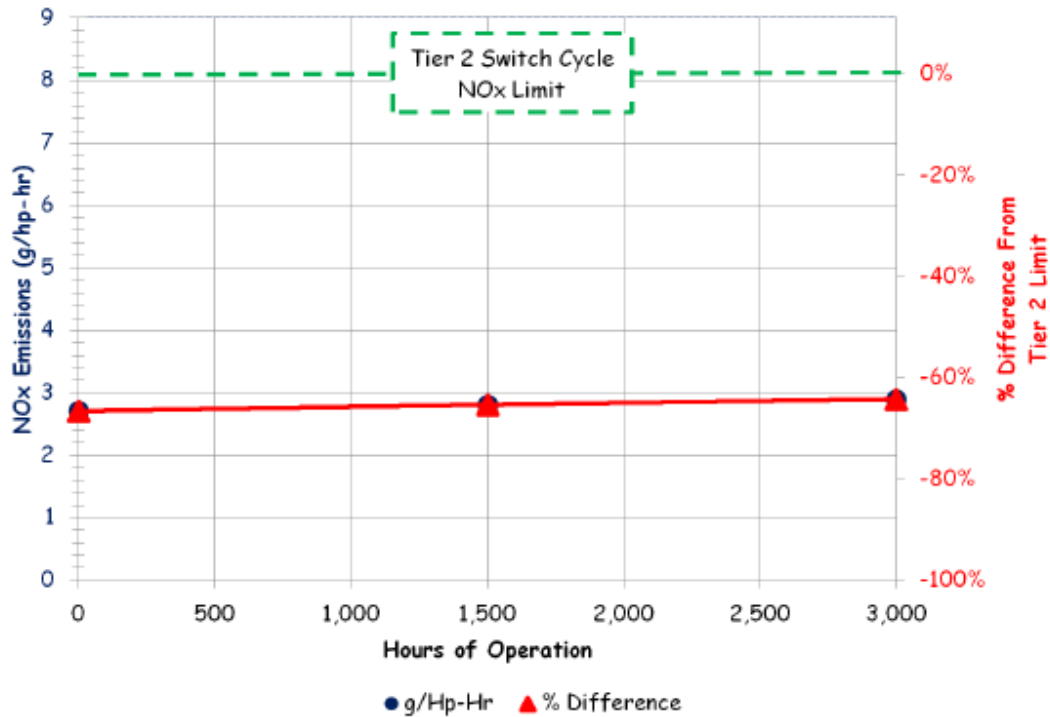
There was a small change in Switch Cycle NOx emissions over the duration of the project. Figure 7 shows that the Switch cycle NOx emissions were below the NOx emissions

limit of 3.0 g/Hp-Hr, which is the level that the locomotive was certified, and about 65 percent below the Tier 2 emissions level of 8.1 g/hp-hr.

Figure 7. Switch Cycle NOx Emissions Trend

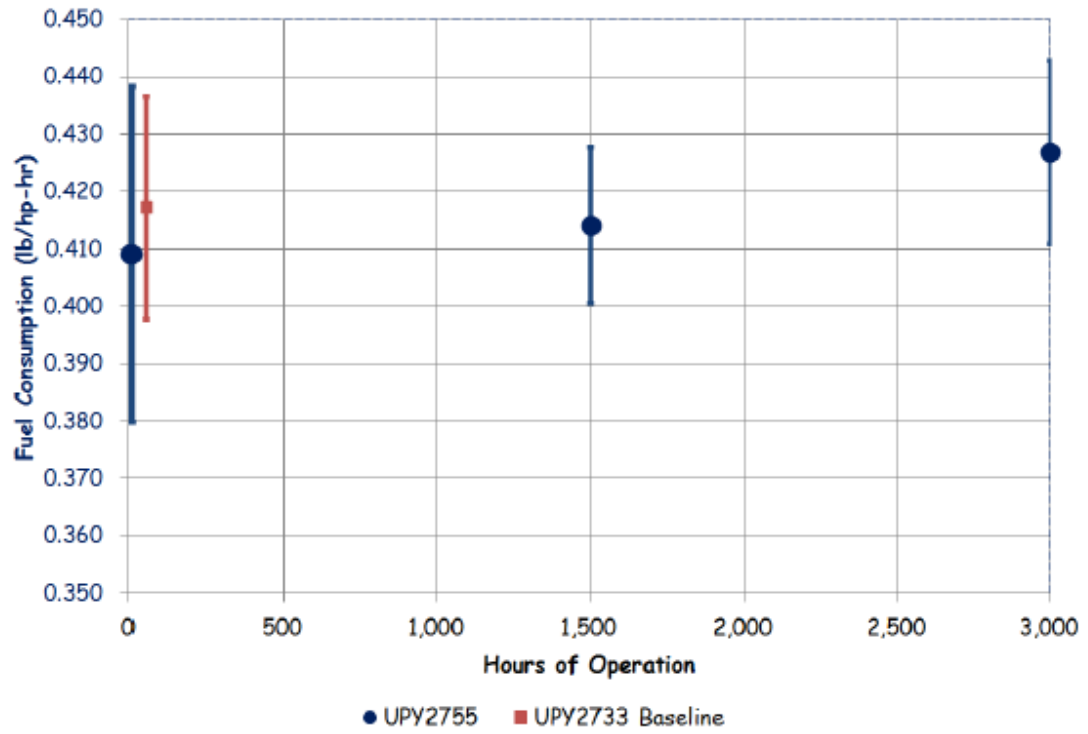
Figure 8 shows the Switch Cycle brake specific fuel consumption (BSFC) for UPY2755 with the L-CCRT DPF installed, and the baseline test on UPY2737. Shown are 95 percent confidence intervals for the triplicate FTP tests, generated using the "confidence.t" function in Excel. Given the overlapping confidence intervals, the test data indicates that there was no statistically significant change in Switch cycle BSFC between the baseline UPY2737 without the L-CCRT and UPY2755 with the L-CCRT, nor was there a statistically significant change in Switch cycle BSFC for UPY2755 during the 3000-hour validation test.

Figure 8. Switch Cycle Brake Specific Fuel Consumption

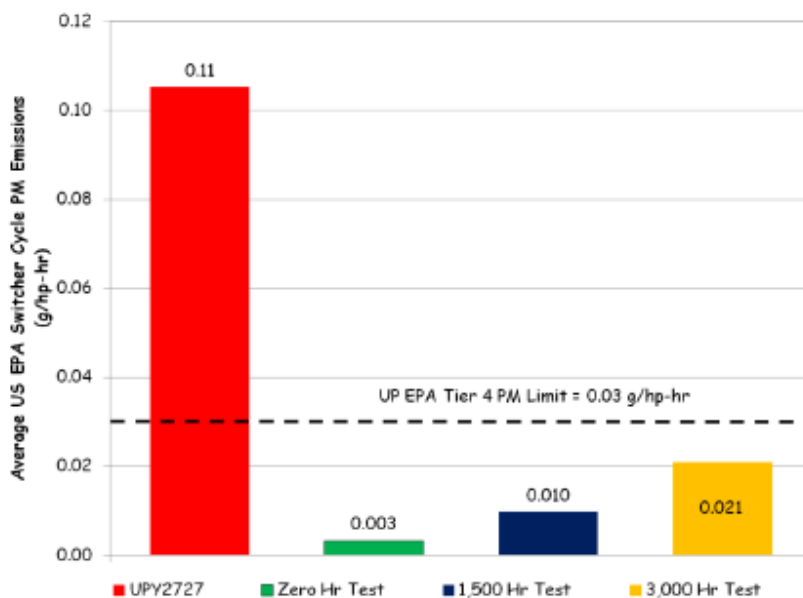
Figure 9 shows the average US-EPA Switch Cycle PM emissions for the “zero-hour” tests were 0.003 g/hp-hr, which was 97 percent below the baseline engine-out PM emissions measured on UPY2737, and 89 percent below the US EPA Tier 4 PM limit of 0.03 g/hp-hr. The 1,500 hour test average Switch Cycle PM emissions were 0.010 g/hp-hr over the US-EPA Switch Cycle, or 68 percent below the Tier 4 PM limit of 0.03 g/hp-hr. During the final emissions test at 3,000 hours, the PM emissions were 0.021 g/hp-hr, or 30 percent below the Tier 4 PM emissions standard.

Figure 9. NREC 3GS21B PM Emissions Summary

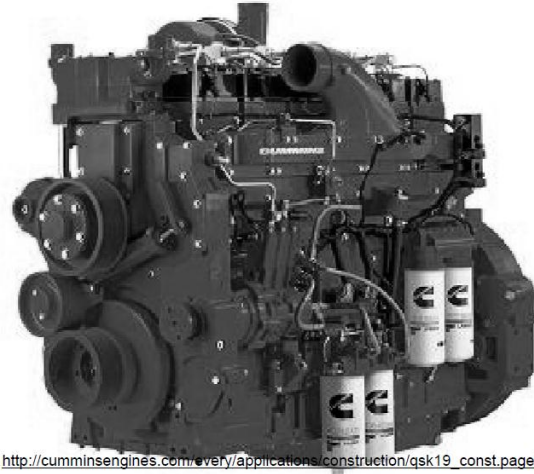
Diesel Engine

- ▣ Powered by 3, diesel engine driven, gen sets.
 - Cummins QSK19C
 - ▣ 19 liter
 - ▣ In-line 6 cylinder
 - ▣ Turbocharged
 - ▣ Air-to-air aftercooled
 - ▣ Common Rail fuel injection
 - Essentially US EPA Tier 3 non-road.
 - 522 kW each engine

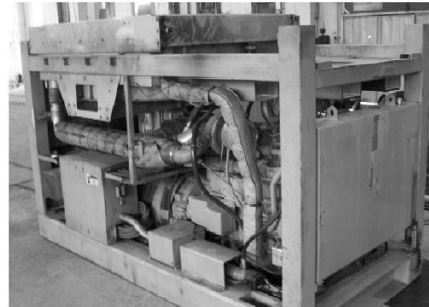
GEN 3 History

- ▣ GEN 3 originally failed May, 2011.
 - During rated power operation to de-greening JM DPF.
- ▣ Failure caused coolant to enter the oil sump.
- ▣ GEN 3 was replaced in June 2011 with used Pod provided by UP.
 - Unknown history of replacement POD.
- ▣ UPY2755 returned to revenue service in California to continue DPF durability testing

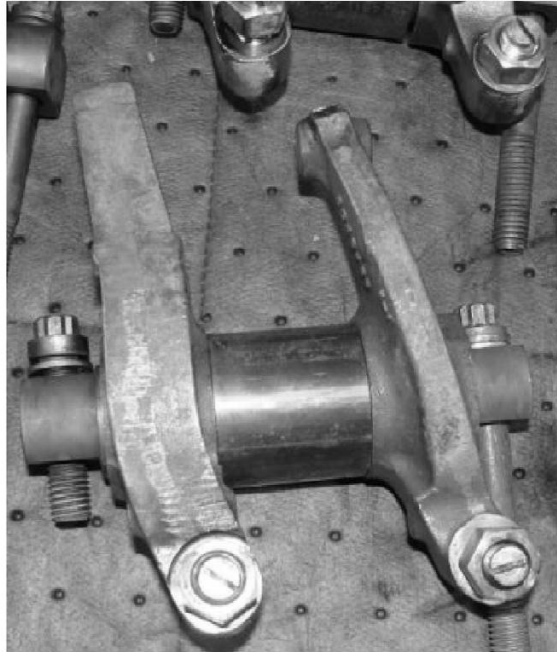
- ▣ Rocker arms & push tubes inspected to assure no issues due to hydraulic lock.
 - ▣ Found minor surface rust on rocker arms.
 - ▣ Rocker arm bearing were found to be in good shape.
 - ▣ No damage to rocker arm or push tubes.
- ▣ Pistons checked at TDC to determine if rods were bent.
 - ▣ No issues found.

Parts Inspection - Surface Rust on Rocker Arms

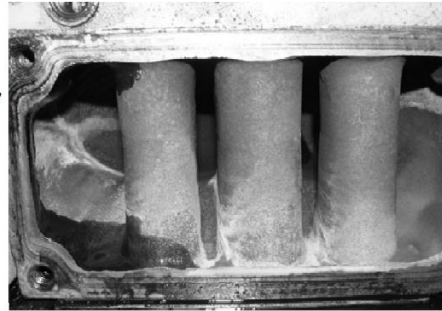
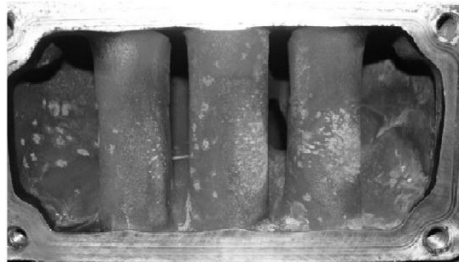
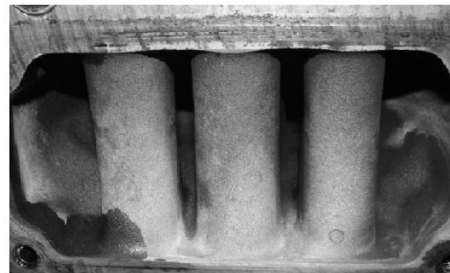
- ▣ Removed intake manifold and found water stains in majority of cylinder ports.
- ▣ Signs of surface rust in most intake ports.

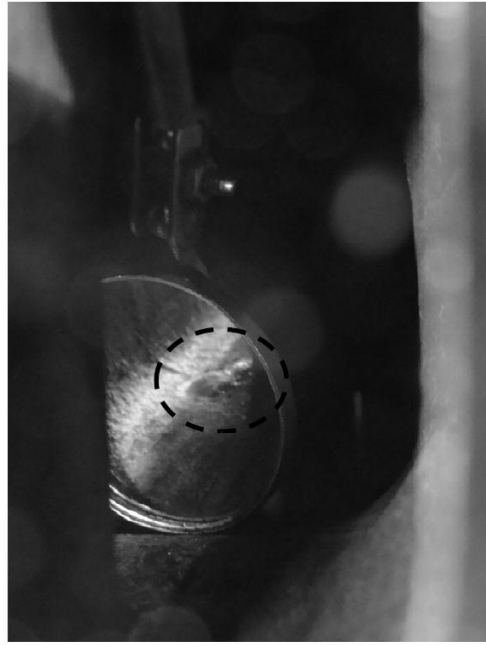
Parts Inspection - Cylinder Heads

- ▣ Close inspection of the cylinder heads showed a possible casting flaw in intake port could be initial cause of coolant leak.
 - Signs of water deposits downstream of flaw.
 - Only visible with inspection mirror.
 - ▣ Shown with red circle in photo.

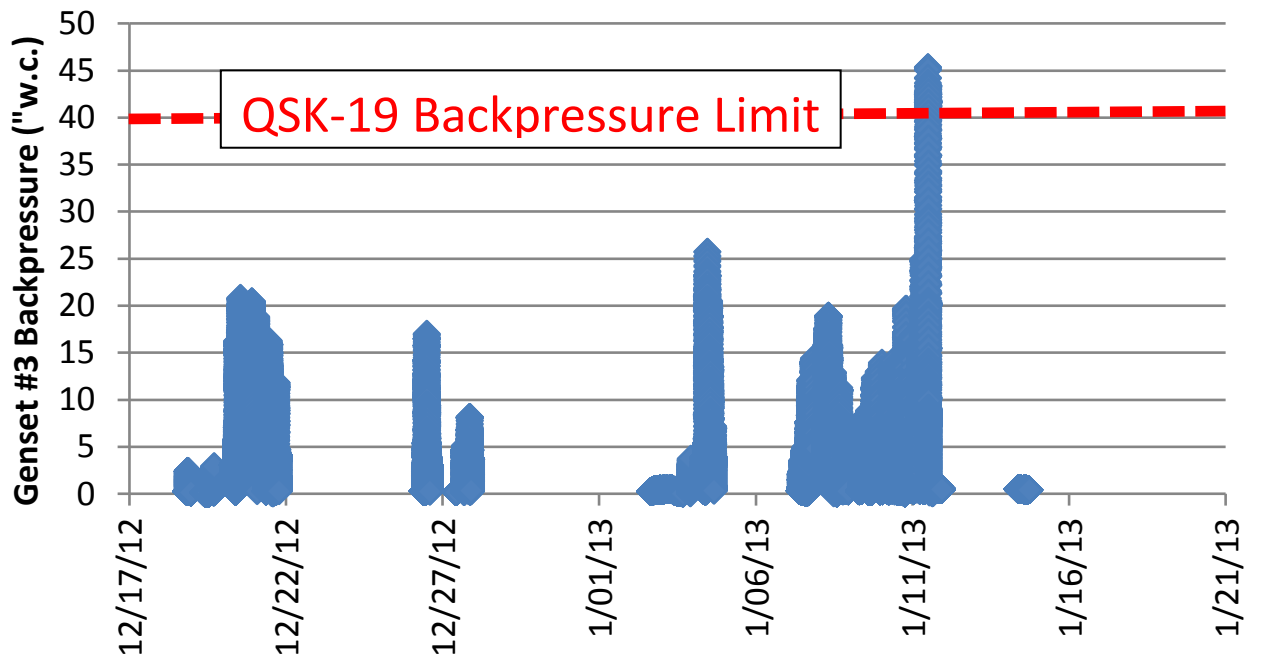
The primary indicator demonstrating a malfunction in the system was the rapid increase in backpressure, which was being monitored with the onboard data acquisition system. As shown in the figure below, the backpressure exceeded 40" w.c. (engines OEM maximum operating pressure) to a pressure of 47" w.c., in January 2013. Since the 3 systems operated well below the maximum threshold for the first 2600 hours, it was a surprise to see one system, gen #3, to exceed it within a very short period of time. Once this trend was found, the engine was removed from operation, and the inspection of the #3 generator system was requested. This effect was isolated to Genset #3, after inspection of the filters and catalyst elements; it was found that unburned hydrocarbons and an excess level of soot accumulation on the face of these elements were exhibited. Inspection of the L-CCRT filters of Genset #1 and 2 found normal conditions, as was indicated by the backpressure monitoring trend. However, as shown in the photographs below, the filters were saturated with the excess hydrocarbons from the increased oil consumption of the engine.

Figure 14: EGP of Genset #3 before the incident and during the January 2013 sudden EGP increase
