**AIR QUALITY IMPROVEMENT PROGRAM (AQIP)
(Pursuant to AB 118)
ADVANCED TECHNOLOGY DEMONSTRATION PROJECT**

**Final Report of Tier IV Particulate Matter Retrofit System on
UPY-2755 (Genset Switch Locomotive)**

December 2, 2013

Prepared by:
Jose G. Ramirez
Sr. Project Engineer, Johnson Matthey SEC LLC

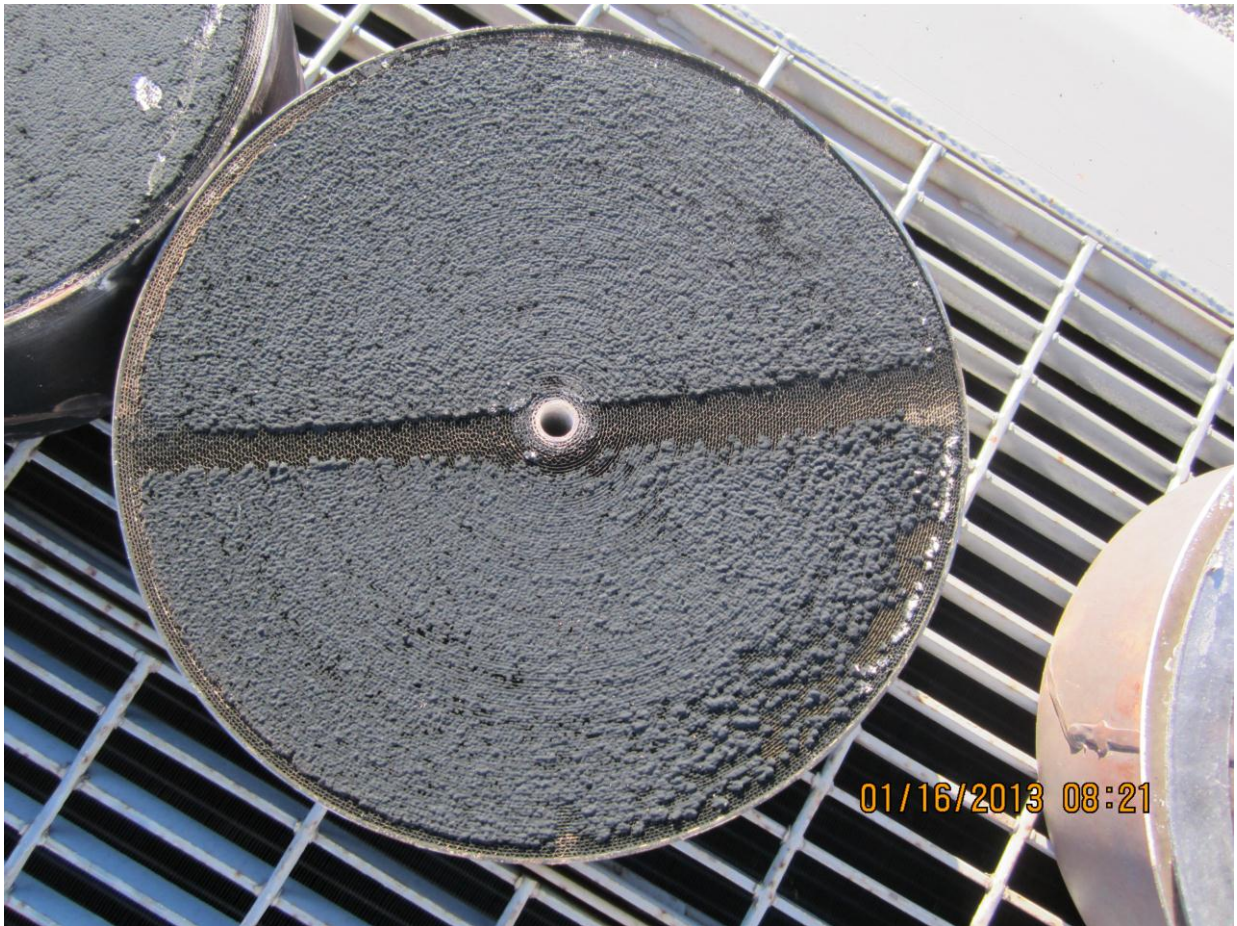
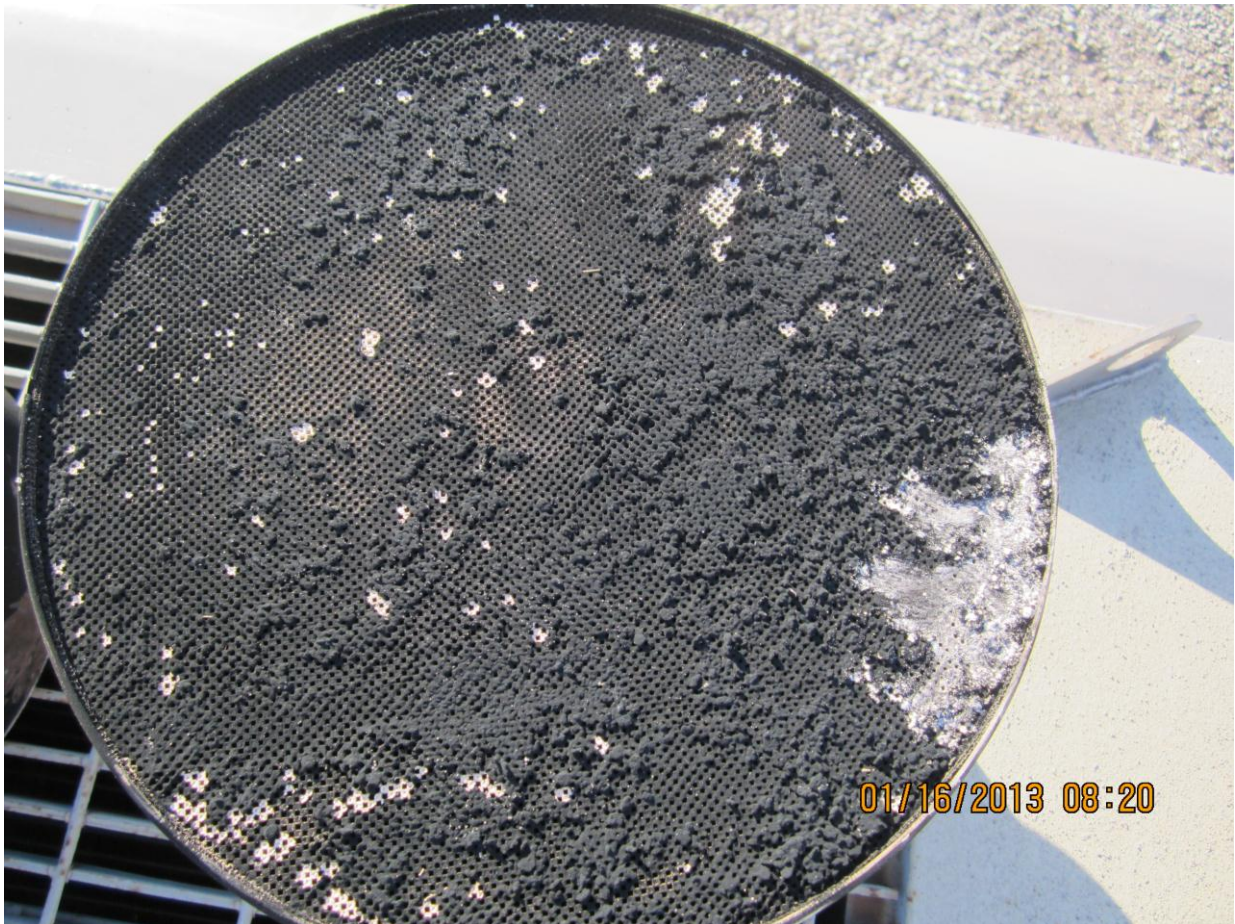
As shown in the photos above and below, the DOC's from Genset #3 were masked with unburned hydrocarbons and excess soot accumulation.

After meeting with the members of the AQIP project, it was agreed that the filters and catalyst elements could be cleaned via CARB approved cleaning methods. After the filters and catalyst elements were cleaned, and the engine was repaired, the switch unit was re-assembled and returned to revenue service. As shown in Figure “13: EGP at Notch-3 for zero-hour, 1500-hr and 3000-hr FTP tests, 95% C.I. error bars,” the performance of the L-CCRT™ returned to normal operation after the repairs and maintenance.
